## The Old Mill / An t-Seann Mhuileann

The Old Mill and the neighbouring Millbrae Cottage at Bunessan were acquired by the Ross of Mull Historical Centre in 2001. Millbrae Cottage was opened in 2009 as a small museum, an office and an archive storage space and has been open to the public since then. The Old Mill is a ruinous shell and has become increasingly fragile over the last 20 years. It is now at a stage where it needs consolidation work to ensure it is safe enough for activities in and around Millbrae Cottage to continue.

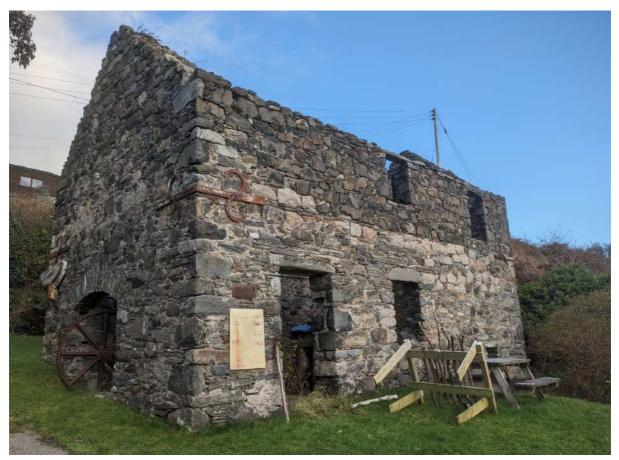
Above: the old mill in November 2023, the water-wheel sat against the right hand gable

The power was provided via a mill lade, that diverted water from the burn, giving a 20 foot head of water to power the over-shot water-wheel. Traces of the lade can still be seen running alongside the road above the mill to Linne a Dhuais. Unfortunately the line of the lade was blocked by the construction of the new road and it is not currently thought to be feasible to reinstate the supply.

During the nineteenth century the 11 foot diameter wheel was replaced with a larger one of 14 foot diameter and grooves from both can still be seen in the end wall of the mill. The wheel shaft passed through the end wall of the building and connected to a series of cog wheels that turned the large mill stones. Although no longer intact, some of the millstones and machinery can still be seen in and around the building.

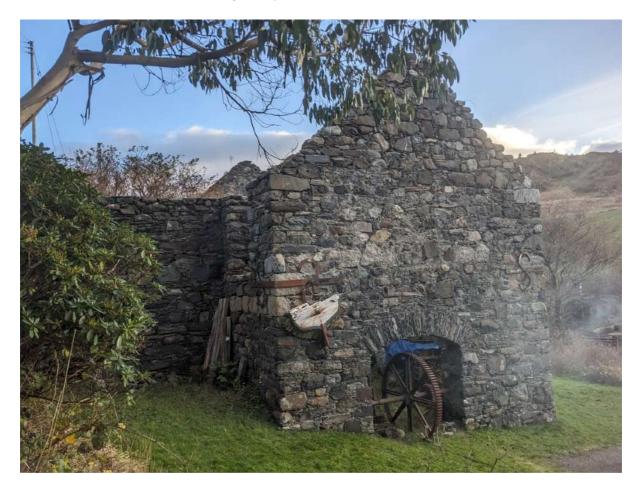
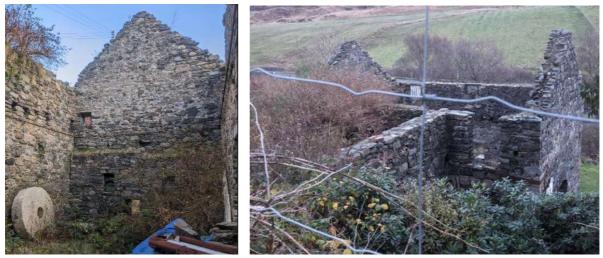
Above: views of the old mill in November 2023
